PROPERTY CONDITION REPORT

CLIENT:	Your Name
INSPECTION ADDRESS:	308 Kansas City Rd. Lee's Summit MO 64063
AGENT:	Your Agent
DATE:	7/21/2017
INSPECTOR:	Steve Rodriguez
REPORT #:	20170720-Sample- Full6yearold

308 Kansas City Rd.
Lee's Summit MO 64063

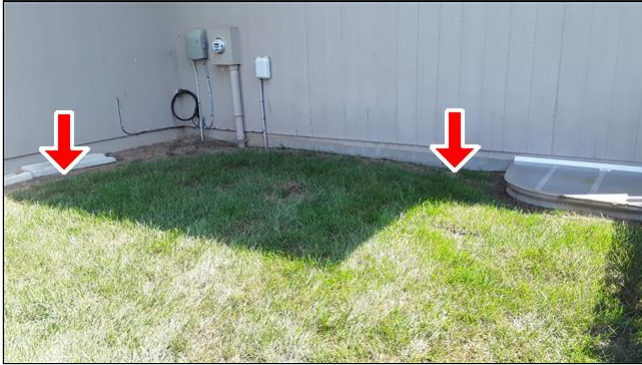
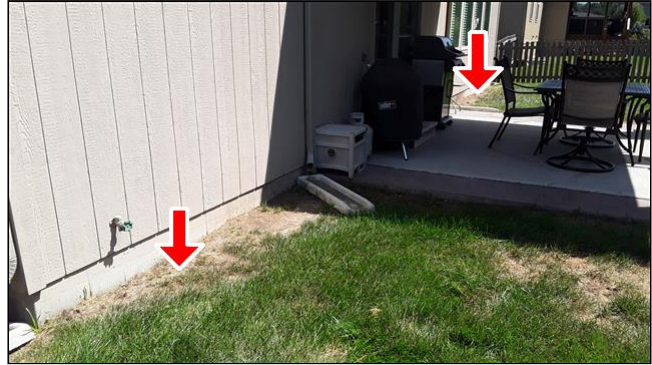
Landscaping is flat and slopes toward foundation on North and West sides of home. This is a typical condition found in many homes. Recommend sloping grading away from home 1" per foot out to 6 feet to avoid grading erosion and possible foundation movement (85-90% of all foundation moisture problems can be avoided with proper grading and downspout extensions). None visible during time of inspection.

1.0 Item 1(Picture) - Landscaping is flat on North side of home

1.0 Item 2(Picture) - Landscaping is flat on West side of home

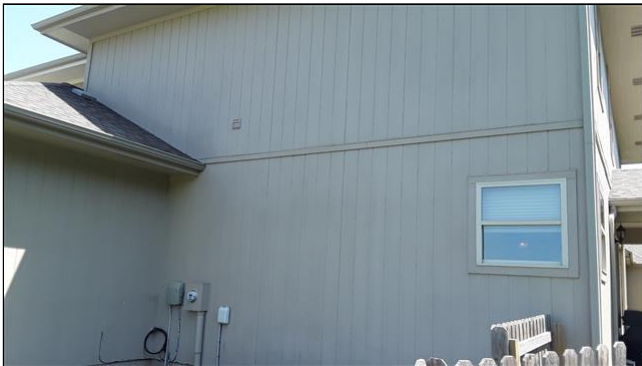
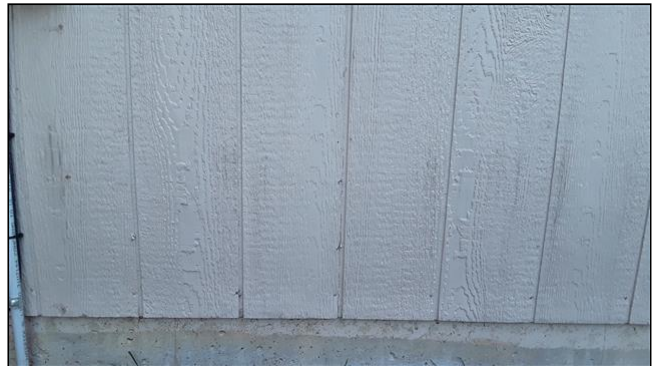
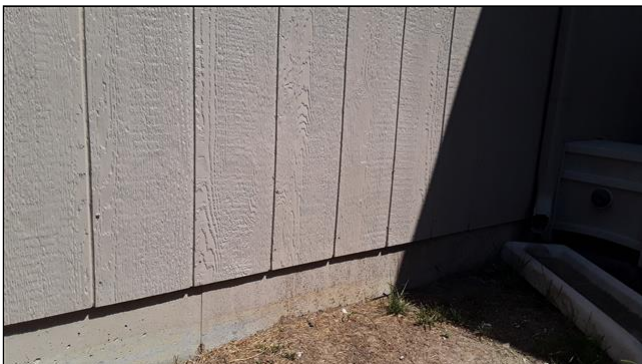
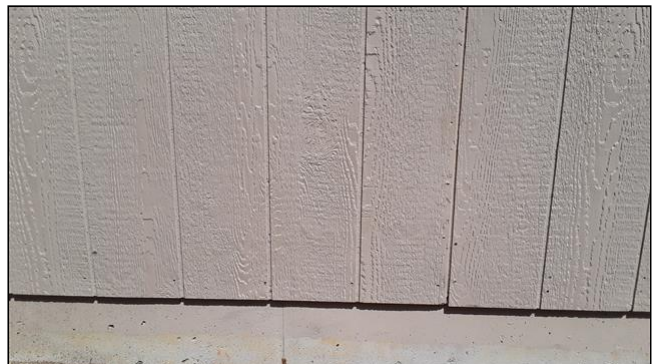
Open gaps and exposed nail heads at siding on North and West sides of home. Recommend properly prepping and painting to avoid possible moisture penetration and underlying moisture damage. None visible during time of inspection.

2.1 Item 1(Picture) - Open gaps and exposed nails on North side of home

2.1 Item 2(Picture) - Close-up of exposed nails and open gaps on North side of home

2.1 Item 3(Picture) - Exposed nails at NW corner of home

2.1 Item 4(Picture) - Close-up of exposed nails at SW corner of home

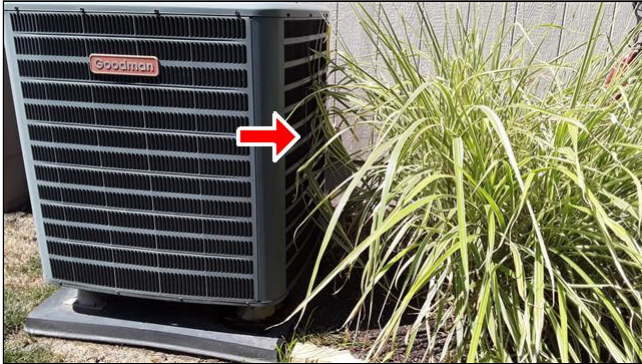
Vegetation in contact with A/C condenser. Recommend keeping all grass/vegetation trimmed at least 12" away to avoid interference with proper function and maintain airflow to unit. Unit operates properly during time of inspection.

3.0 Item 1(Picture) - Vegetation against A/C condenser

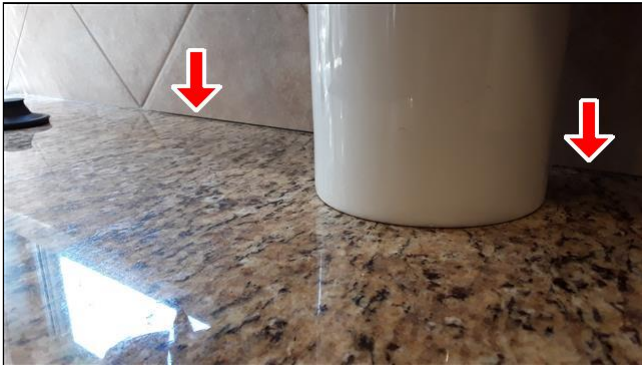
Deteriorated grout at countertop. Recommend properly regrouting to avoid moisture damages to underlying framing areas. None visible during time of inspection.

9.8 Item 1(Picture) - Deteriorated grout at kitchen countertop

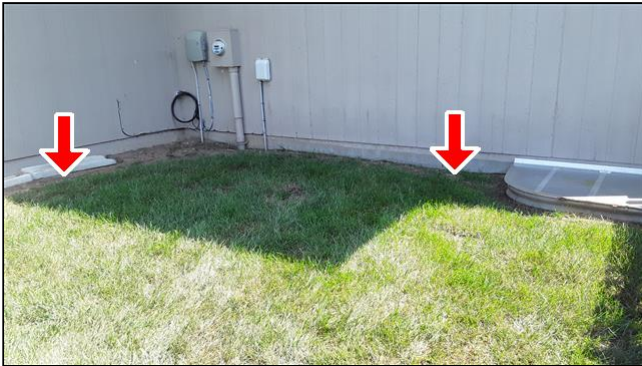
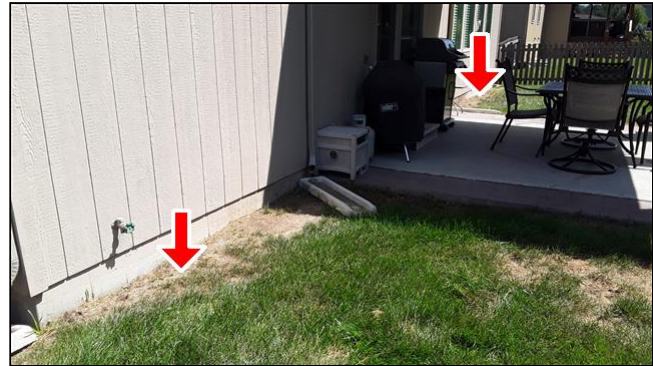
Landscaping is flat and slopes toward foundation on North and West sides of home. This is a typical condition found in many homes. Recommend sloping grading away from home 1" per foot out to 6 feet to avoid grading erosion and possible foundation movement (85-90% of all foundation moisture problems can be avoided with proper grading and downspout extensions). None visible during time of inspection.

1.0 Item 1(Picture) - Landscaping is flat on North side of home

1.0 Item 2(Picture) - Landscaping is flat on West side of home

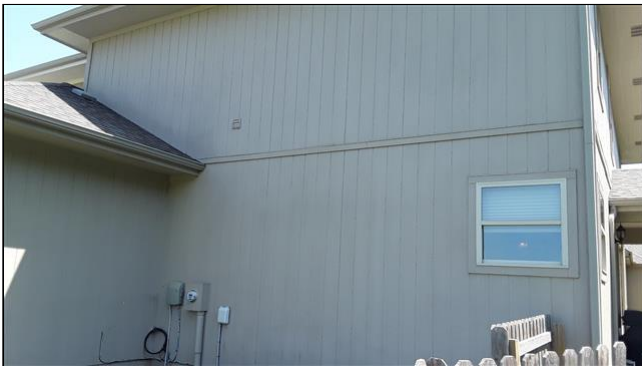
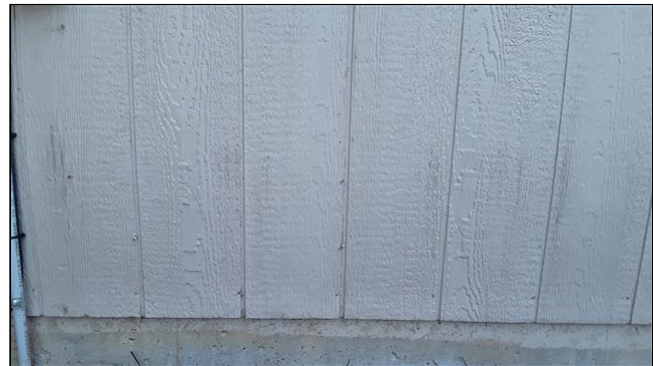
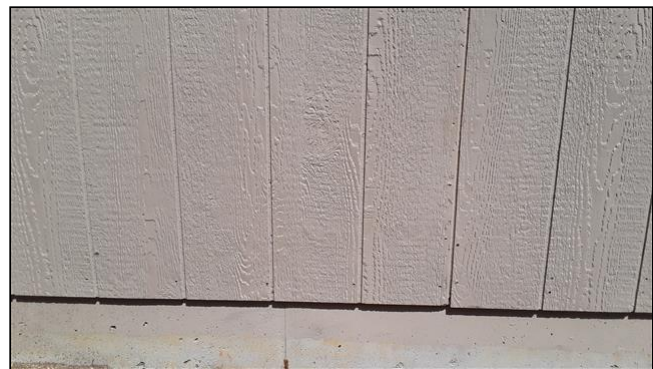
Open gaps and exposed nail heads at siding on North and West sides of home. Recommend properly prepping and painting to avoid possible moisture penetration and underlying moisture damage. None visible during time of inspection.

2.1 Item 1(Picture) - Open gaps and exposed nails on North side of home

2.1 Item 2(Picture) - Close-up of exposed nails and open gaps on North side of home

2.1 Item 3(Picture) - Exposed nails at NW corner of home

2.1 Item 4(Picture) - Close-up of exposed nails at SW corner of home

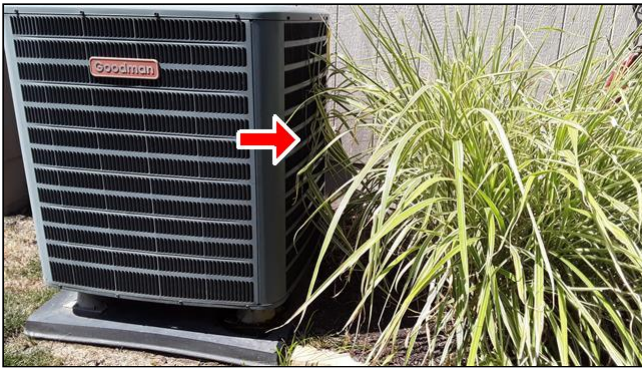
Vegetation in contact with A/C condenser. Recommend keeping all grass/vegetation trimmed at least 12" away to avoid interference with proper function and maintain airflow to unit. Unit operates properly during time of inspection.

3.0 Item 1(Picture) - Vegetation against A/C condenser

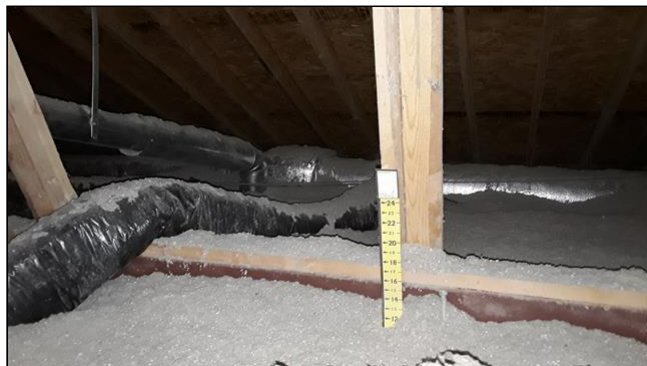
12-14 inches of blown cellulose insulation present. U.S. Department of Energy recommends R-38 rating in attic spaces, which equates to 11-13 inches. No additional depth needed.

5.1 Item 1(Picture) - 13 inches of blown cellulose insulation in attic

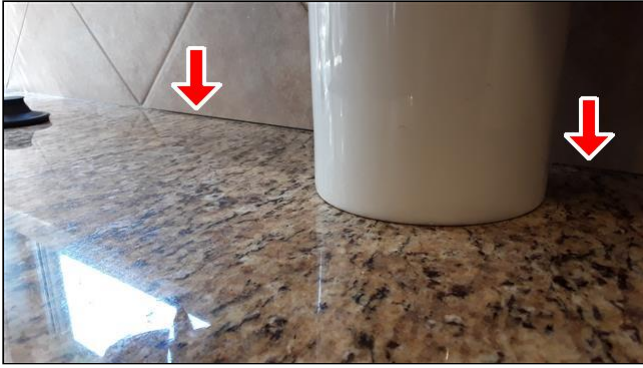
Deteriorated grout at countertop. Recommend properly regrouting to avoid moisture damages to underlying framing areas. None visible during time of inspection.

9.8 Item 1(Picture) - Deteriorated grout at kitchen countertop
